# Manhole Inspection Summary

Manhole # S33CC\_043MH

Insp Date: **3/1/07 11:31 AM**

**Location** Address: **1100 PARK AVE**

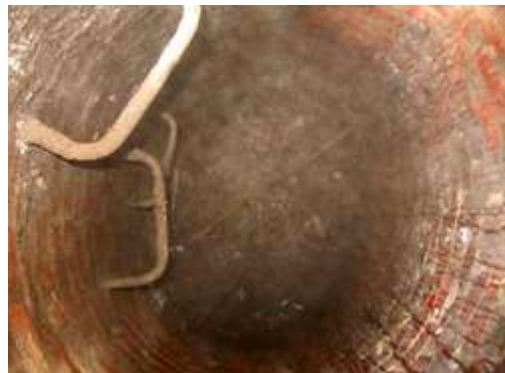
Top View

☒ **Debris** (not Condition related)

Count: **5** Missing: **0** ☒ **Corroded**

Corroded steps. Channel debris.

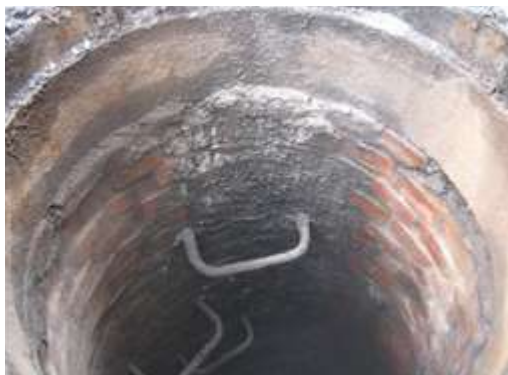
Defect

Condition: ☐ Sound ☐ Cracked ☒ **Leaks**

Condition: ☐ Sound ☐ Cracked ☐ Root Intrusion ☐ Loose Brick ☒ **Deteriorated**

Infiltration: ☐ None ☒ **Joint** ☐ Cracks ☒ **Mortar** ☐ Roots ☐ Wall

Infiltration: ☐ None ☐ Joint ☐ Cracks ☒ **Mortar** ☐ Roots ☒ **Wall**

Frame leaks. Adjustment deterioration and infiltration. Corbel infiltration - other side.

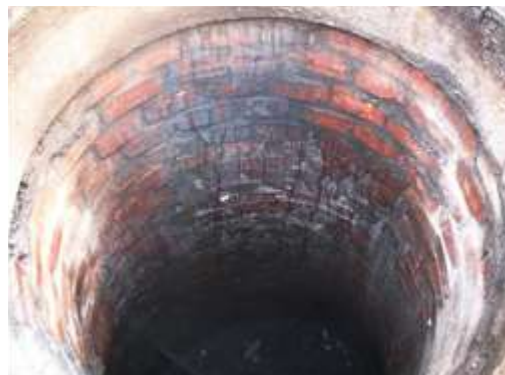
Defect

Frame leaks. Adjustment deterioration and infiltration. Corbel infiltration.

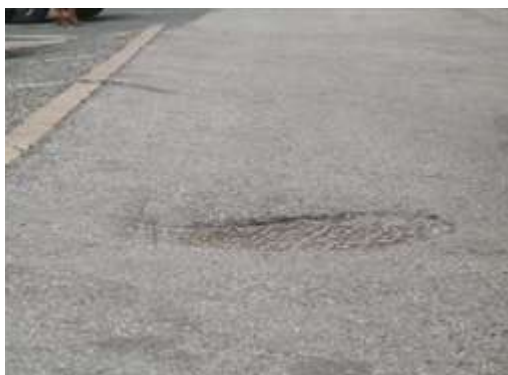
Defect

Subject To Ponding: **Ponding**

Subject to ponding.

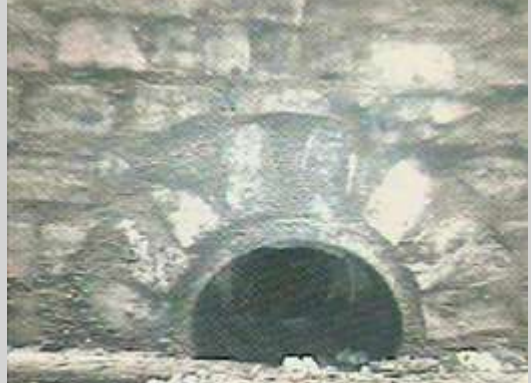
8 in. Circular Gravity Sewer  
Pipe Out @ 12 O'Clock

Deposits: ☐ None ☒ **Mud** ☐ Sludge ☒ **Debris** ☐ Grease

Silt Depth: **1** (in.) Deposits Extent: **Light**
